David & Megan Gee  
22201 NE 28<sup>th</sup> Place  
Sammamish, WA 98074

**Re: Public Comment for May 7, 2013 City Council Meeting**

This critical areas report has been prepared to satisfy the City of Sammamish Critical Areas Study (SMC 21A.50) report requirements and is being submitted as part of an application for a residential development permit on properties owned by David and Megan Gee. The two subject properties are King County Tax parcels 0224069024 and 0224069025. Both parcels are located on the west shore of Beaver Lake within the City of Sammamish (Figure 1). An existing single family residence and stand along garage are found at 2112 W Beaver lake Drive SE. The other parcel to the south is undeveloped. The current pending application is for modifying the existing single family residence on the more northerly of the two parcels.

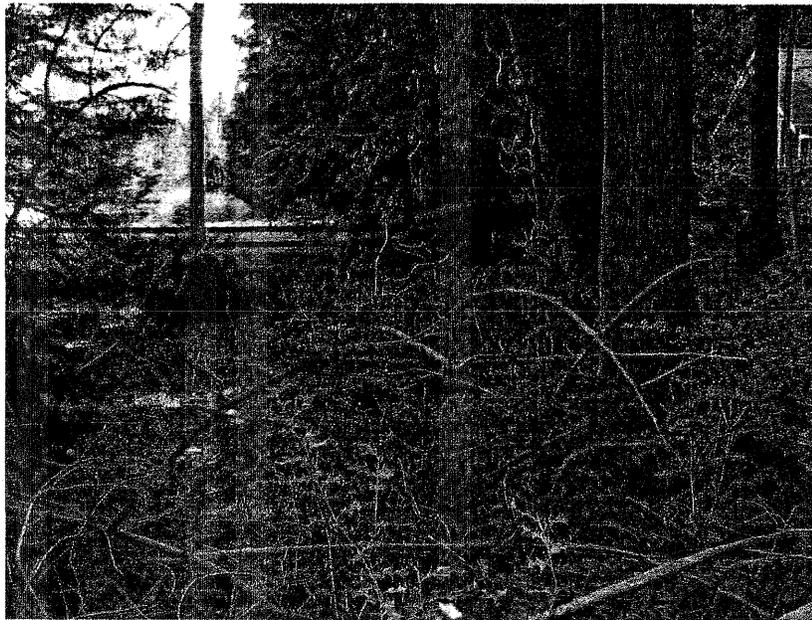
**Photograph 2** – Looking S at shallow inundation within the western part of the depressional wetland on April 9, 2009.

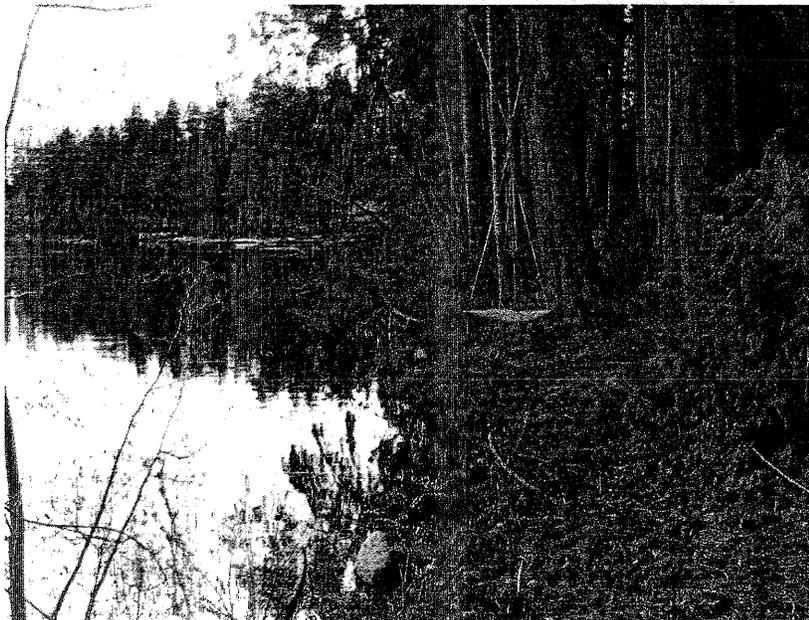
**Photograph 6** – Looking south southwest along the shoreline of Beaver Lake on April 9, 2009 from the existing dock. Water level appears to be at the OHWM.

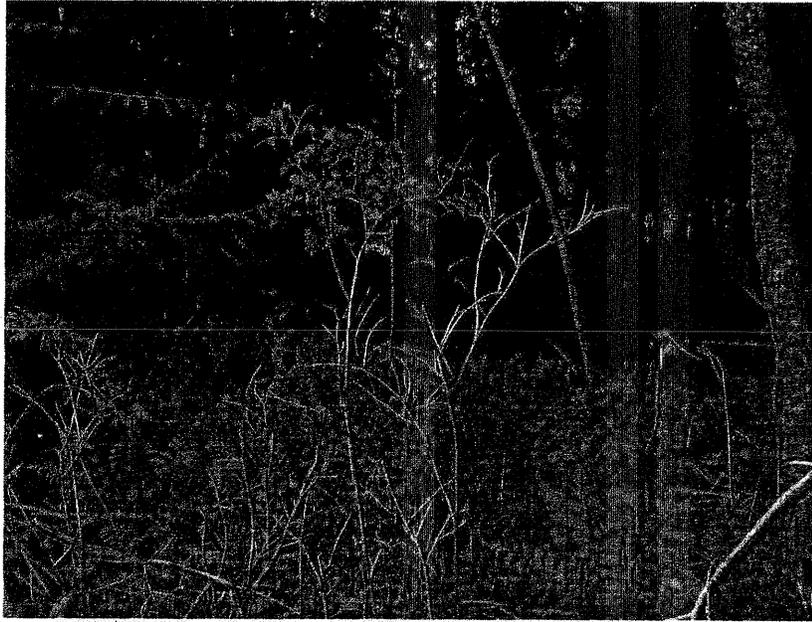
**Photograph 7** - Looking N from wetland boundary flag A-1 on the fence at dense lady fern in the eastern part of the depressional wetland on May 4, 2009.

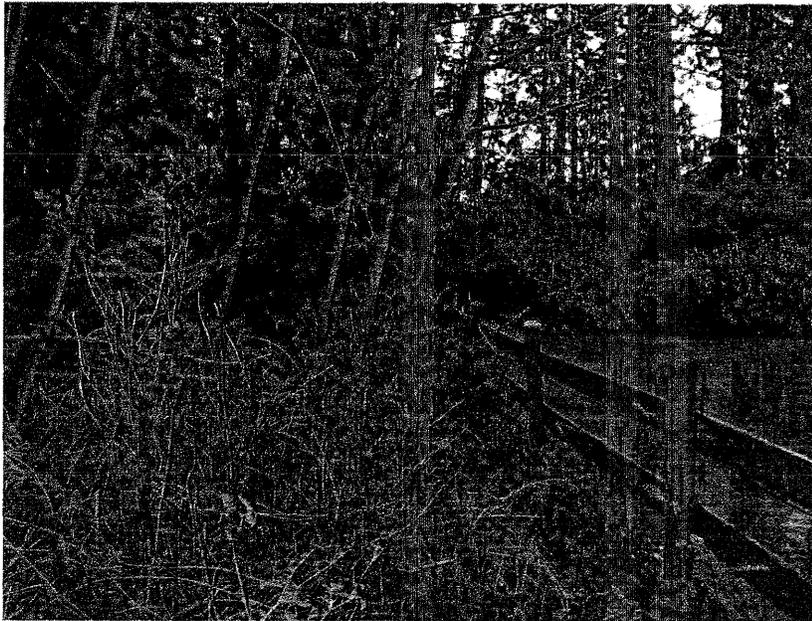
**Photograph 8** - Looking E at early seral phase vegetation (red alder and other species common in disturbed areas) at the southern boundary of the site within SP-6.

Only one of the three parameters was met and this was marginal (hydrophytic vegetation). As noted above, the vegetation is more likely indicative of past disturbance than hydrologic and edaphic conditions. Because indicators of hydric soils and wetland hydrology are not present, this sample plot and community were determined to be upland deciduous forest. Photographs 8 and 9 in Appendix C show this cover type.

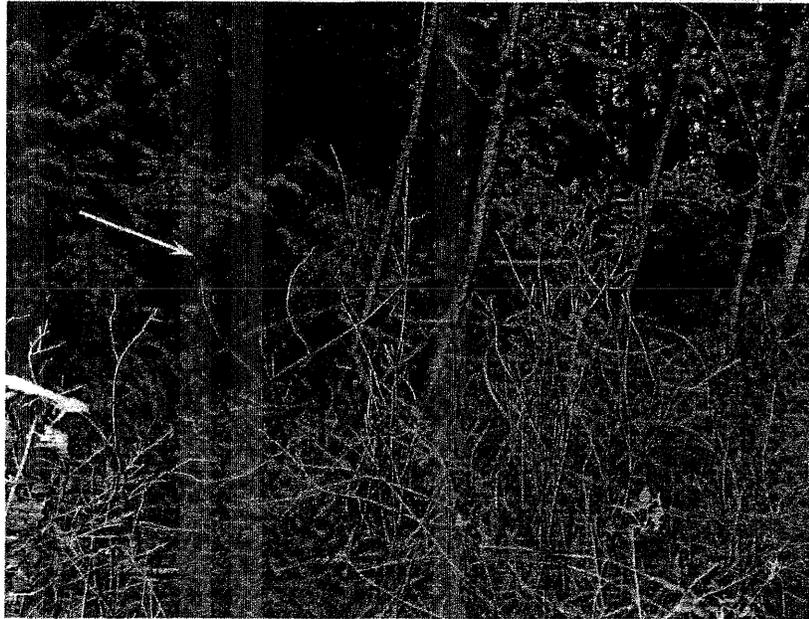
**Photograph 9** – Looking ENE along the delineated wetland boundary (arrow) at the blue SP-6 sample plot flag (~5" dbh red alder) from the Oregon ash tree located at the southern boundary of the wetland on May 4, 2009.

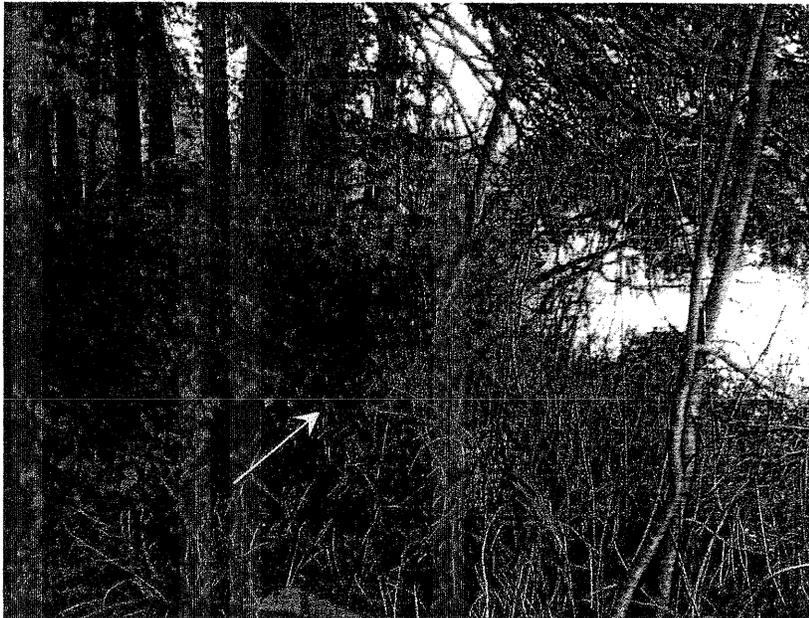
**Photograph 10** – Looking north northeast along the shoreline from the existing dock at the ecotone (arrow) of wetland (slough sedge) and upland (salal) vegetation on April 9, 2009.

ESA Adolfson indicated that there was a narrow lake fringe wetland. There are some emergent and scrub-shrub wetland plants including yellow-flag iris (*Iris pseudacorus*), slough sedge, and spiraea (*Spiraea douglasii*) along the shoreline extending from the northeast corner to perhaps 75 feet south of the existing dock. ENVIRON concurs with this assessment. However, as noted above, this lake fringe wetland appears to be entirely waterward of the OHWM. Per SMC 21A.50.290(2), the setback standard for lakes and ponds specified above would be applicable. Photographs 10, 11, and 12 in Appendix C show the OHWM and this narrow fringing wetland associated with Beaver Lake.

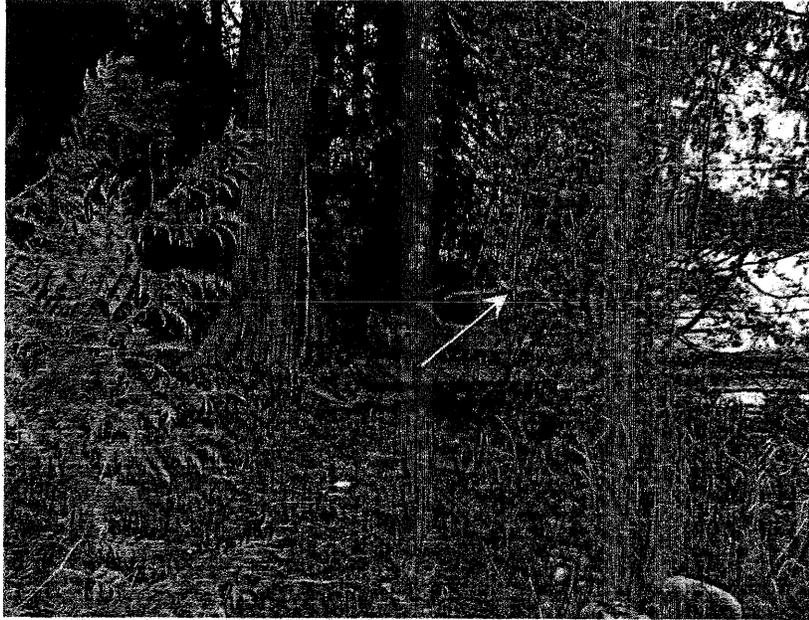
**Photograph 11** – Looking N at the existing dock and blue flagging marking the ordinary high water mark (arrow) on May 4, 2009.

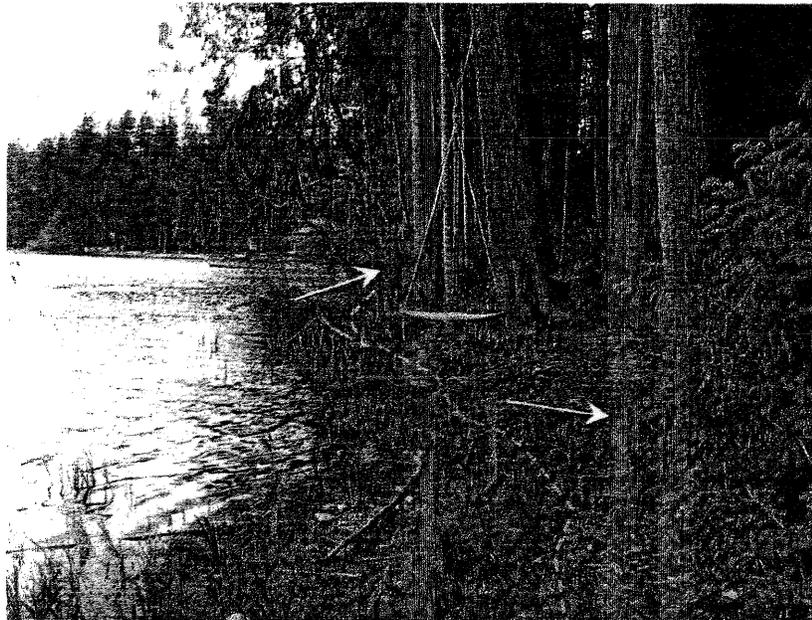
**Photograph 12** – Looking SSW along the OHWM (dashed yellow line) on May 4, 2009. The blue OHWM flag in the foreground was tied to the nearest permanent vegetation just upslope. The extent of yellow-flag iris is a good indicator of the OHWM.

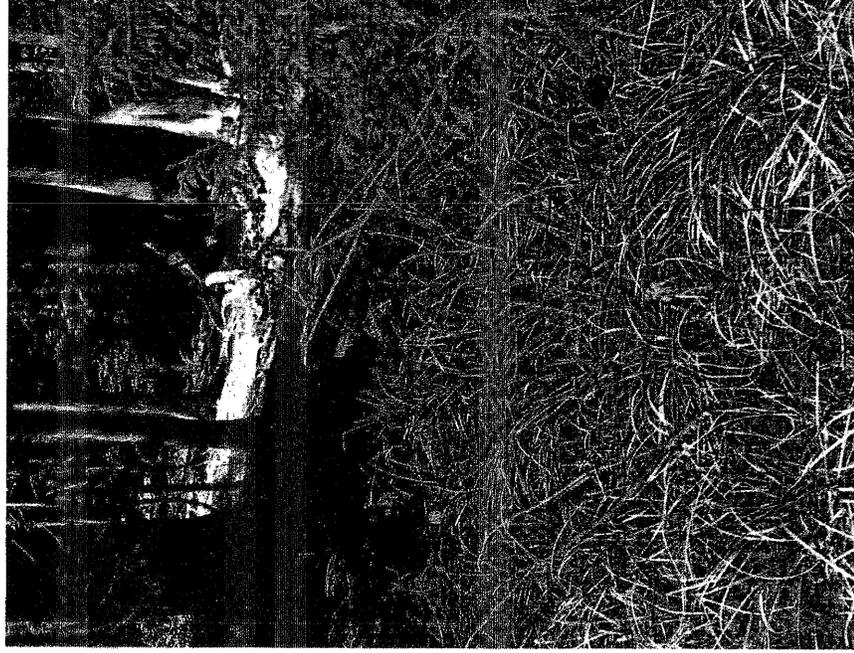
**Photograph 14** – Looking north northwest at a stand of slough sedge (obligate wetland plants) at the south edge of the depression.
