SAMMAMISH WATER QUALITY MONITORING

Annual Report 2023

Since 2019, the City of Sammamish has contracted with King County to expand water quality monitoring within the city. This annual report provides a brief overview of activities and results from 2023. It does not include all water quality monitoring within Sammamish, but only covers the activities (described below) that are part of this specific contract.

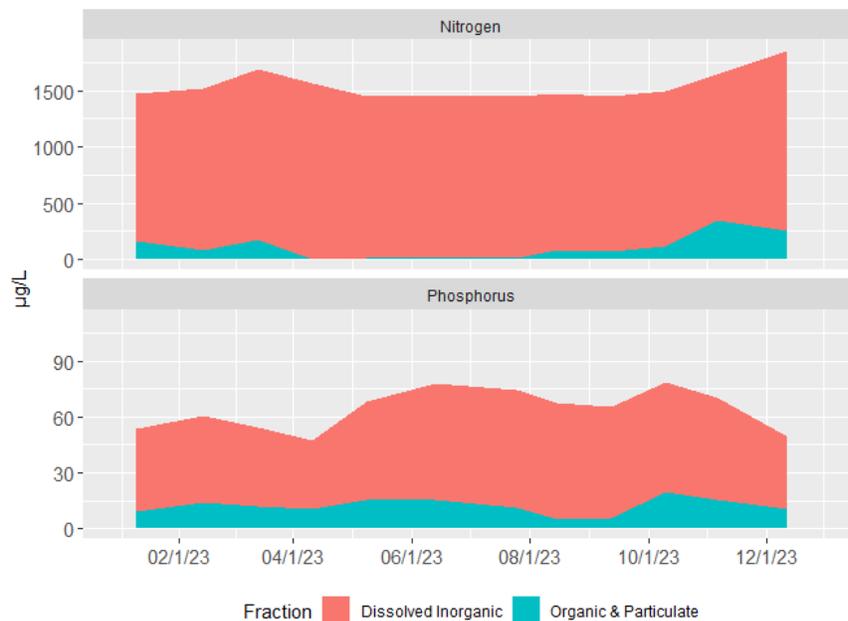
Nutrients

The following graphs show nitrogen and phosphorus concentrations, split out into two fractions: dissolved inorganic, and organic plus particulate. The dissolved-inorganic fraction can be taken up and used more readily by algae (many organic and particulate forms need to be decomposed first). These are stacked-area graphs; the total height of the colored area is the total concentration.

In 2023, Zackuse Creek continued to have fairly high nutrient concentrations. This is typical of streams in Sammamish and is not unique to Zackuse. Continuing to reduce nutrient inputs to these streams, especially phosphorus, would likely benefit Lake Sammamish. Lake Sammamish, designated a Water of Statewide Significance, has had a Lake Management Plan in place since 1994 to reduce phosphorus.

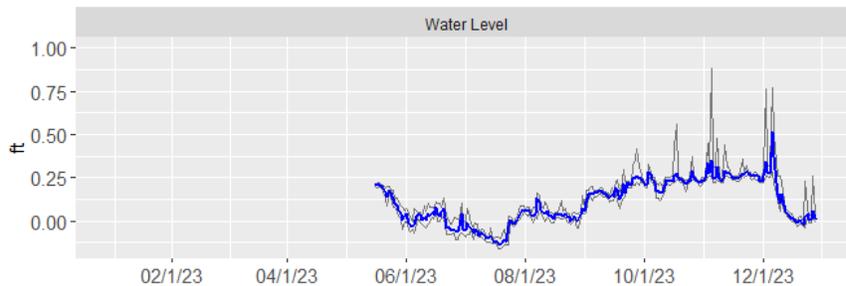
Culvert water level

In 2023, we added a water-level gage at the culvert under East Lake Sammamish Parkway. This site is not suitable for good streamflow measurements, so we have not converted water level into streamflow. Instead, this gage focuses on understanding how the stream and culvert respond to large rainstorms, which can deposit substantial amounts of gravel and sediment in and near the culvert.

The blue line shows daily average values, and the thinner grey lines show daily maximum and minimum values.

Starting in 2023, a second gage measured water level at the East Lake Sammamish Parkway culvert.
