From: Erica Tiliacos <etiliacos@att.net>
Sent: Tuesday, April 24, 2012 5:02 PM
To: Evan Maxim
Cc: Debbie Beadle; Stahl Ilene
Subject: ECA comment
Attachments: Booth_Henshaw_AGU_Land_Use_Watersheds copy.pdf

Rates of Channel Erosion in Small Urban Streams

By Derek B. Booth and Patricia C. Henshaw

in M. Wigmosta, ed., *Stream Channels in Disturbed Environments: AGU Monograph Series*, in press (antic. publication 9/00)

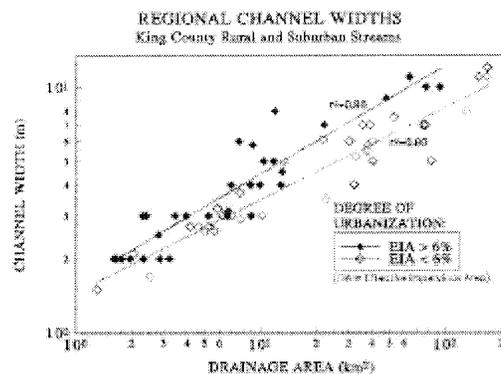
Figure 1. Bankfull channel widths, segregated by percent effective impervious area (EIA; see Dinicola, 1990) contributing to the measurement point. A discrimination at 6 percent EIA was chosen because it approximates the rural-to-suburban transitional land use in this region. From Booth and Jackson [1997].

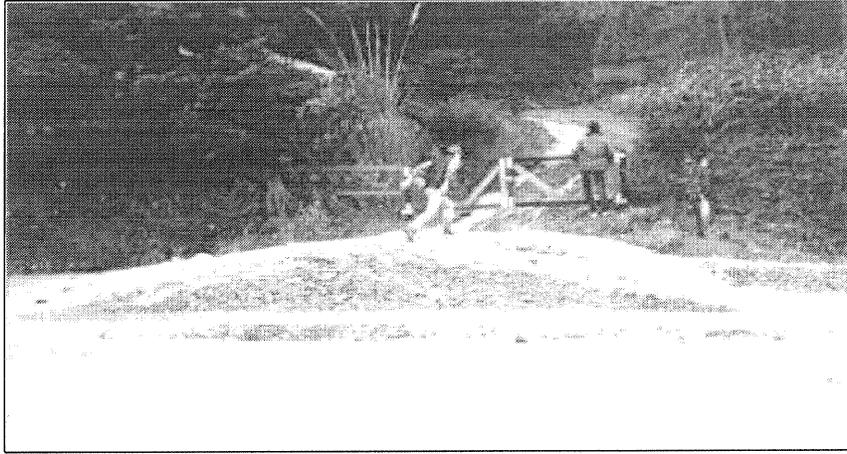
Figure 2. Deposition of stream-channel sediment, eroded from upslope reaches of tributary 0143G (station C8).

The sediment released by this scenario of headwater flow increases may or may not accumulate as it passes through the downstream channel network. The potential input of additional urban-flow-induced sediment from other lateral tributaries will combine to influence whether sediment, eroded from upstream reaches, can remain in active transport or will accumulate in noteworthy volumes. Curiously, the vagaries of human infrastructure, particularly small roadway culverts that were sized and installed during an earlier pre-headwater-development era when only lower discharges of water (and tremendously lower discharges of sediment) occurred, appear to be one of the strongest single determinants of whether the urban channel change is perceived to be mainly a problem of “erosion” or one of “deposition” (Figure 2).

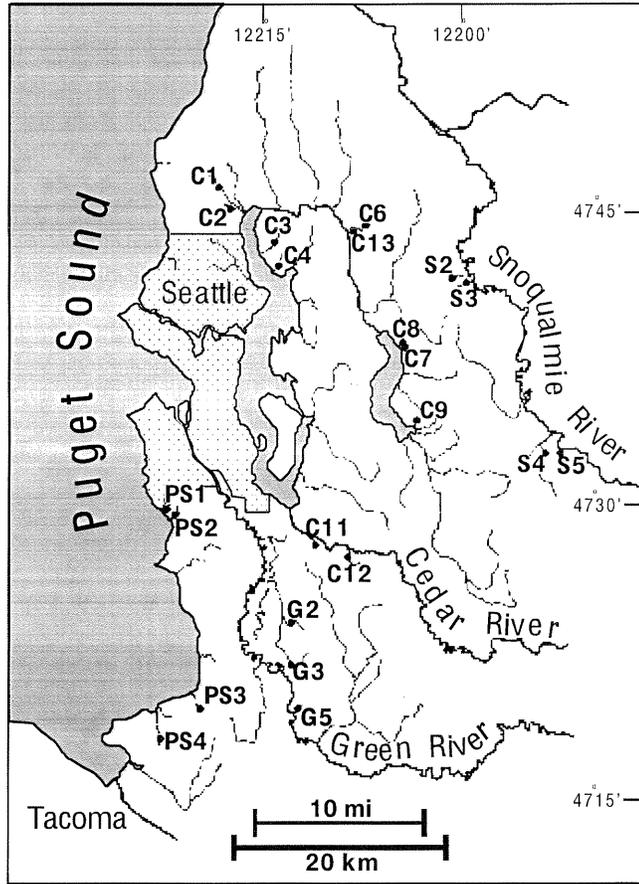
Figure 3. Location of stream measurement stations listed in Table 2.

Figure 7. Maximum 24-hour rainfall for each year of the interval 1988-1996. The chosen gauge (“Maplewood”) was centrally located for the study sites (near station C11 on Figure 3).

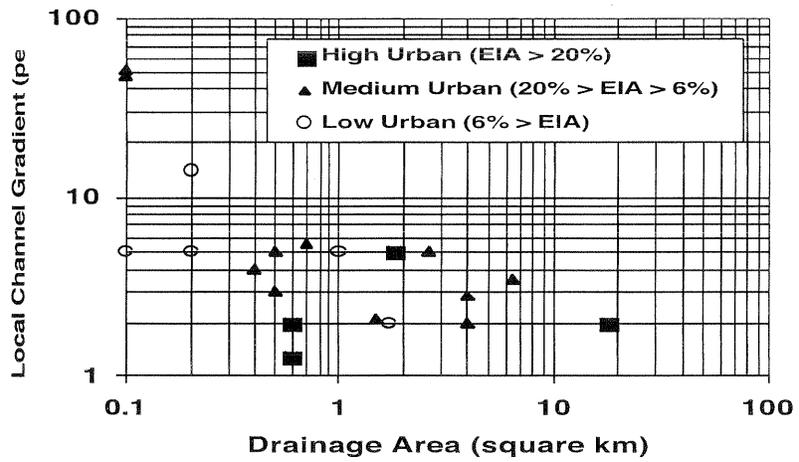
Figure 4. Summary attributes of measurement stations listed in Table 2.

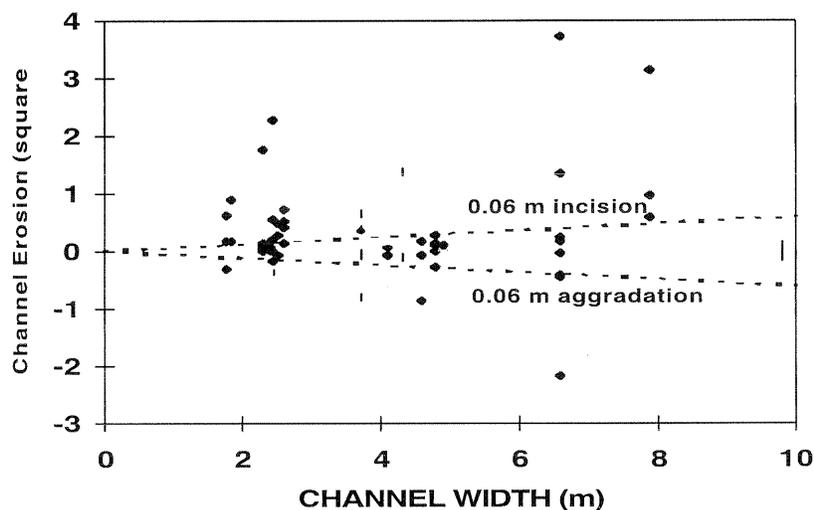
Figure 5. Results of all measurements, expressed as the average change in cross-section area per year between visits. Dotted lines plot the median vertical change of 0.06 m.

Overview. Rates of erosion and deposition vary by over two orders of magnitude (see Figure 5). In this population, the minimum amount of the annual width-averaged vertical channel change was below the level of measurement error (about 20 mm); the maximum was about 1 m per year. Over the 11-year period, 80 percent of all measurements show an annual width-averaged vertical change (erosion *or* deposition) of less than 0.2 meters, with the median of all measurements at 60 mm/year.

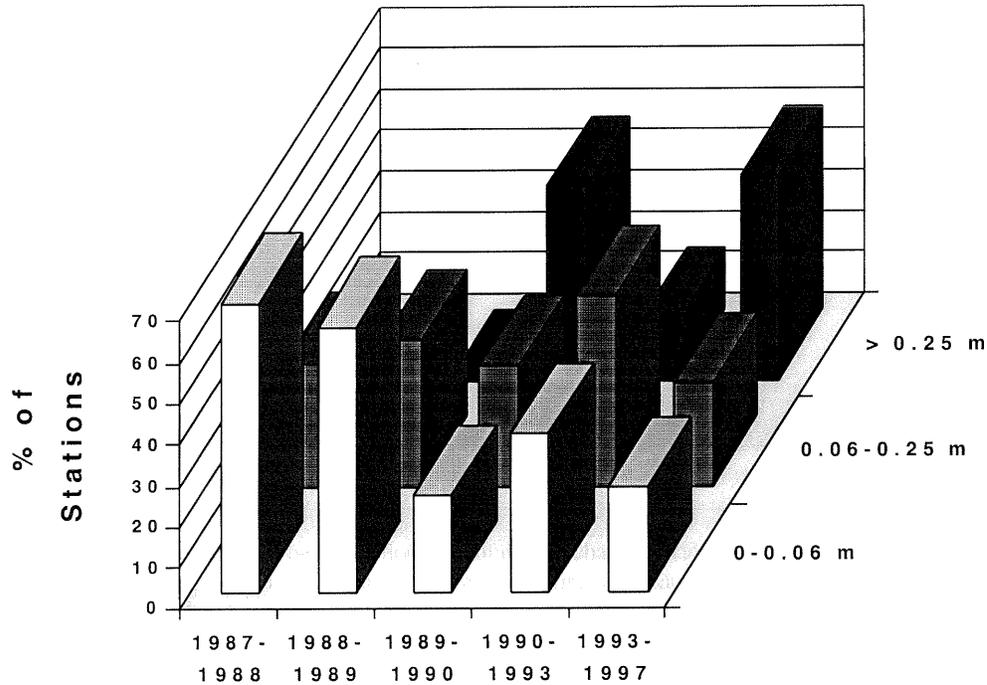
Figure 6. Distribution of stations below, above, and greatly above the median vertical change of 0.06 m/year. Channel changes are calculated across the full period between measurements and are *not* annual averages. Note that the distribution of stations in the 1989-1990 interval is nearly identical to that of 1993-1997, even though the earlier period is only one-quarter as long.

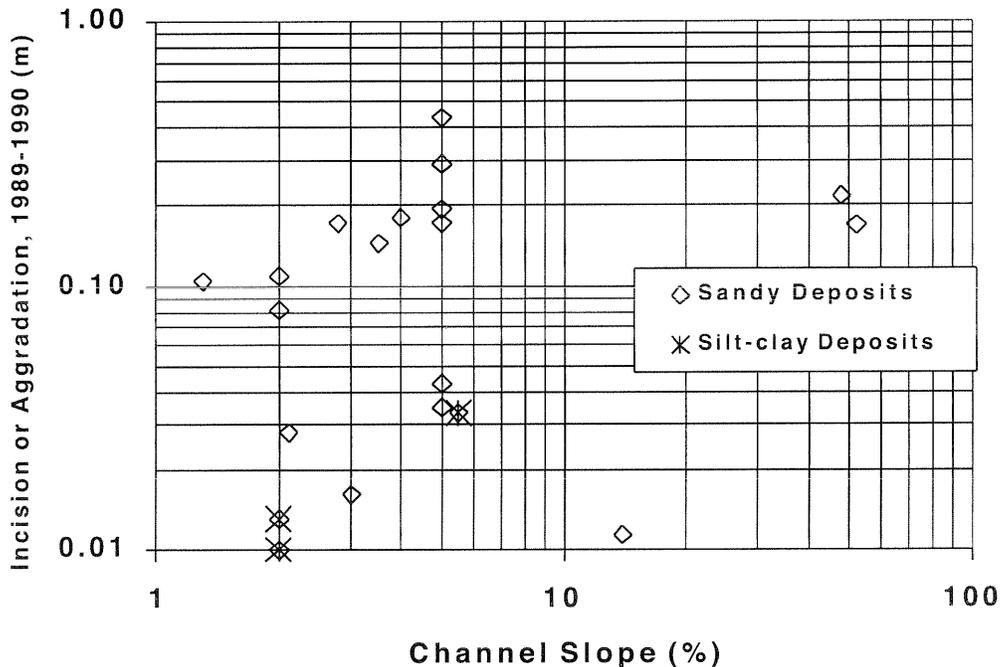
Figure 8. Demonstration of the poor correlation between local channel slope and the magnitude of one year's width-averaged vertical change. A more consistent pattern is suggested by the relatively low change shown at each of the three stations underlain by cohesive (silt and clay) hillslope deposits.

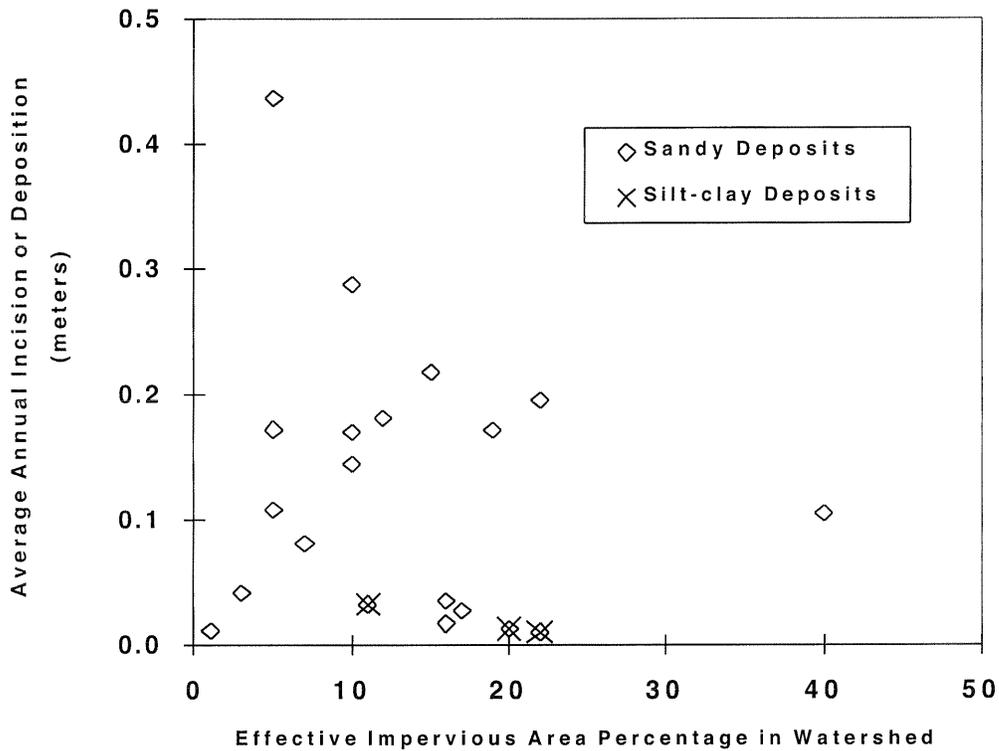
Figure 9. Demonstration of the poor correlation between contributing impervious area and the magnitude of the annual width-averaged vertical change, averaged over the full duration of each station's measurement history.

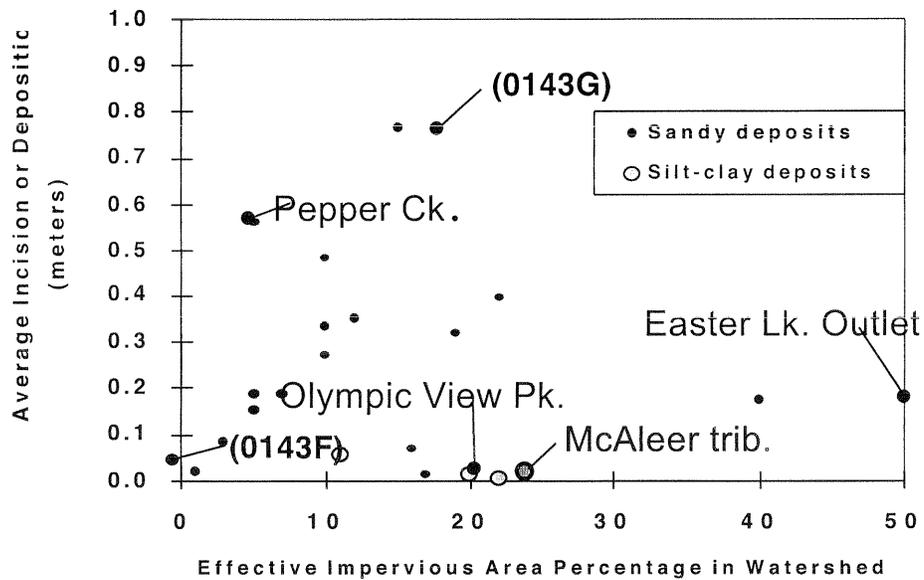
Figure 10. The equivalent parameters as for Figure 9 but considering *only* the measurement interval with the greatest change, 1989-1990. There are no appreciable differences between the pattern expressed by either the single-year or the time-averaged results. Labeled points are discussed in the following section.

Specific Site Conditions (see Figure 10)

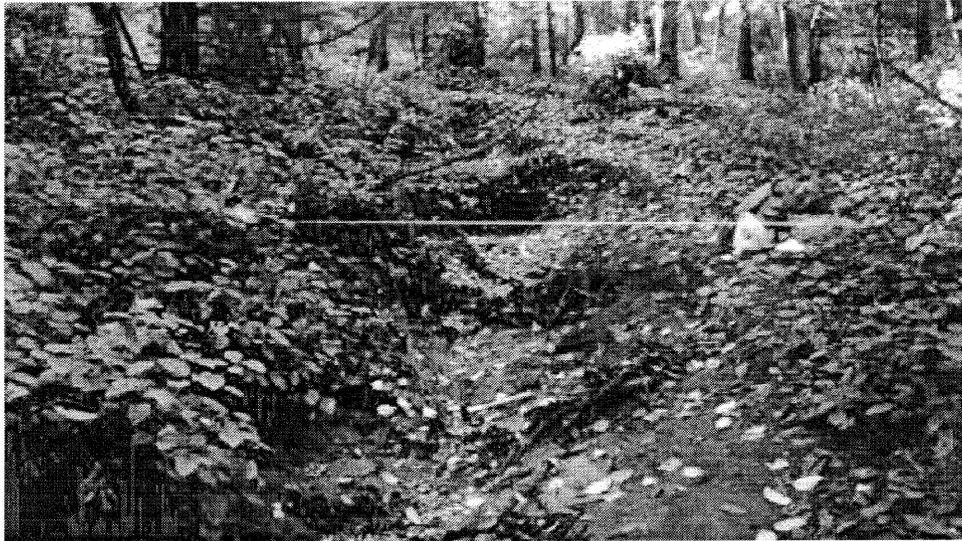
Figure 11. View of the channel of Olympic View Park (Station PS4) in 1986, looking upstream. Line across the channel (below the scale bar) is the tape measure used to determine horizontal distance at the cross section location.

Olympic View Park. This channel is located in a lightly developed parkland (Figure 11), established around the long-protected riparian corridor of the stream. The surrounding watershed has been almost fully developed for several decades, primarily with single-family residences. The ravine that contains the channel and associated park is excavated into deposits of the sandy Vashon advance outwash. Incision has clearly been part of the channel's past history; several hundred meters downstream of the measured cross section, large gabion baskets stabilize what must have been a major knickpoint in the 1970's. Yet the current decade of measurements is noteworthy in its near-negligible change from one year to the next (Figure 12), although the channel morphology is distinctly unappealing from either a biological or an aesthetic standpoint. It is relatively uniform, slightly sinuous, with virtually no heterogeneity or variability in size, shape, or roughness. Much of this uniformity is surely the result of close human contact—foot traffic up and down the channel (commonly dry in the summertime) is frequent, and any sticks or twigs would be promptly "cleaned up." Yet even where encroaching riparian shrubs limit the immediate access of people, conditions are essentially unchanged.

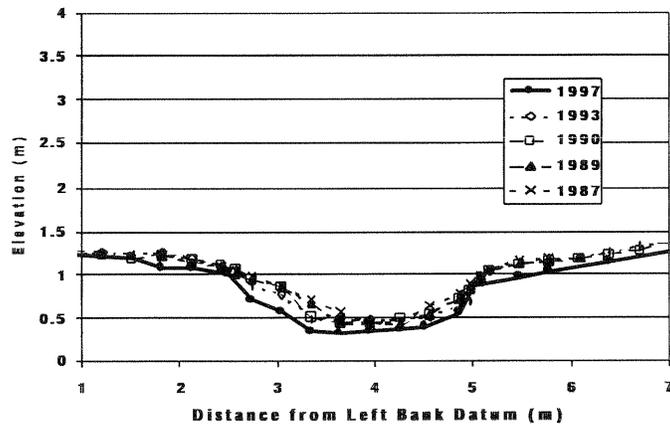
Figure 12. All cross section measurement of Station PS4, showing only minor changes from 1987 to 1993 (the total width-averaged erosion during this interval is 8 cm) and from 1993 to 1997 (total average erosion 7 cm).

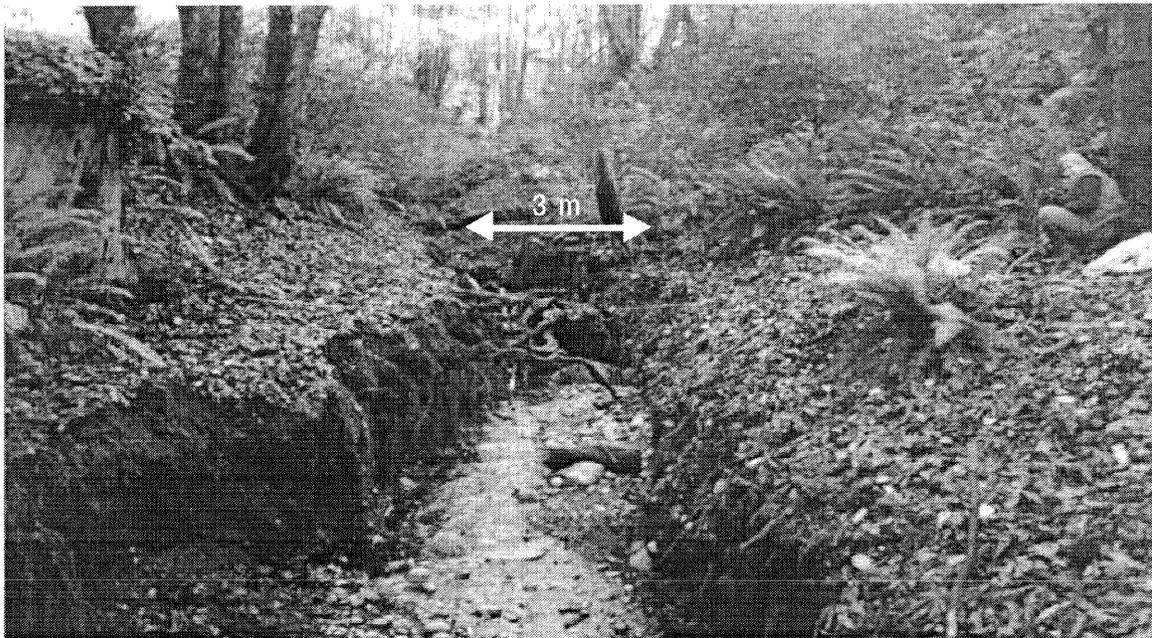
Figure 13. View of the channel of the Easter Lake outlet (Station PS3) in 1986, looking upstream.

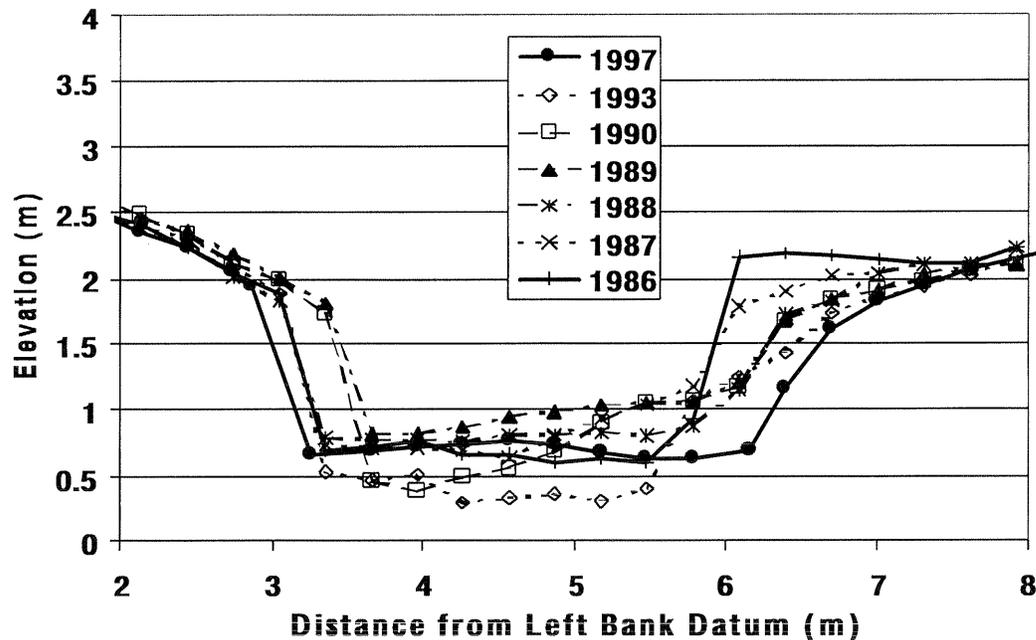
Figure 14. All cross section measurement of Station PS3, showing episodic deepening in 1990 and 1993 but aggradation both before and after. Widening has been progressive but particularly during the interval 1986-1988.

This site displays the interplay of fluvial and hillslope processes and it also demonstrates why cross-sectional measurements can be a very incomplete characterization of stream-channel conditions. Net change at this site has not been dramatic, but bed scour has clearly oscillated with bank failure on a multi-year scale (Figure 14). For example, the steep high right bank remaining after the 1986 storms degraded over the next several years, with progressive bank collapse and channel widening contributing sediment to an aggrading channel bed. Renewed scour during the large flows of January 1990 lowered the bed by nearly 0.5 meters in the active part of the channel, and additional sediment was flushed out through at least 1993. The 1993-1997 interval was a period of substantial channel *widening*; but in contrast to many other stations during this time, channel *deepening* did not occur, and in fact aggradation was substantial.

Changes in channel cross section were accompanied by a progressive simplification of in-stream morphological features. Over the 11 years of observations this stream has become more like a drainage ditch, with a marked lack of heterogeneity in either sediment or bedforms. This has not required any direct human intervention; simplification of the channel, with attendant loss of aesthetic and biological benefits, has occurred only through the indirect effects of watershed disturbance.

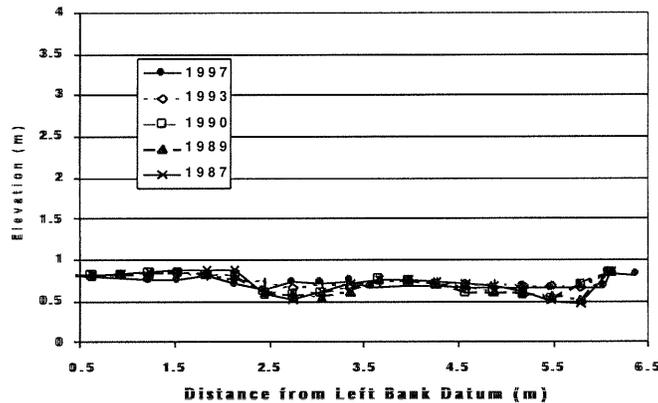
Figure 15. All cross section measurement of Station C2, one of the three sites underlain by cohesive deposits and showing almost no change 1987-1997.

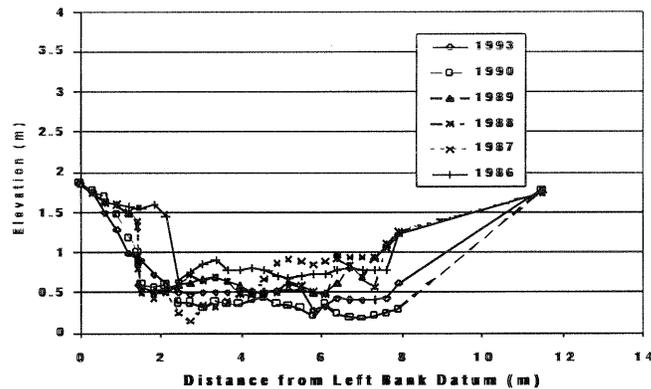
Figure 16. All cross section measurement of Station S3, showing active change in every measurement interval. Vertical exaggeration 2:1 (note expanded horizontal scale).

Pepper Creek. In contrast to the modest changes observed at the previous stations, this site has shown tremendously variable conditions (Figure 16). It collects runoff from a watershed in the very earliest stages of urbanization; the major hydrologic changes have been related to channelization and road-ditch interception of shallow subsurface flow [Burges *et al.*, 1989], whereas the total fraction of contributing imperviousness is still quite low. The channel is extremely well protected from direct human intrusion, lying several hundred (very brushy) meters from the nearest structure or public road and entirely on private property. It is eroded into sandy valley-bottom deposits, delivered by episodic landslides from the surrounding hillsides and locally reworked by past fluvial action.

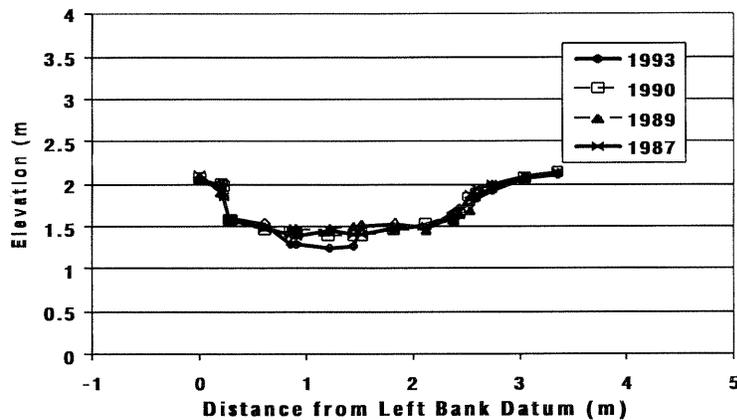
Figure 17. All cross section measurement of Station C9, the Timberline tributary that does *not* receive any appreciable runoff from the stormwater system of the upslope development.

Timberline Tributaries. In a topographic and geologic setting remarkably similar to that of Pepper Creek, these smaller tributaries drain adjacent areas generally subjected to intensive urban development. A primary difference between them, however, is that the upland storm-drain system bypasses one (0143F) and discharges into the other (0143G). The stability of 0143F (Figure 17) throughout the measurement period demonstrates that there is nothing inherently unstable about these channels, even where gradients are steep and deposits are erodible. Curiously, the discharge into 0143G was constructed with some advance awareness of the susceptibility of the downstream channel to erosion: rather than simply releasing the runoff from the end of a pipe, the discharges are first attenuated in a detention pond and then released at the head of a swale through a 20-m-long level dispersion pipe. Despite these efforts, first documented in Booth [1989], channel incision of more than one meter occurred in 1989-1990 (Figure 18). In contrast, the station without such flows remained virtually unchanged throughout the period of its measurement.

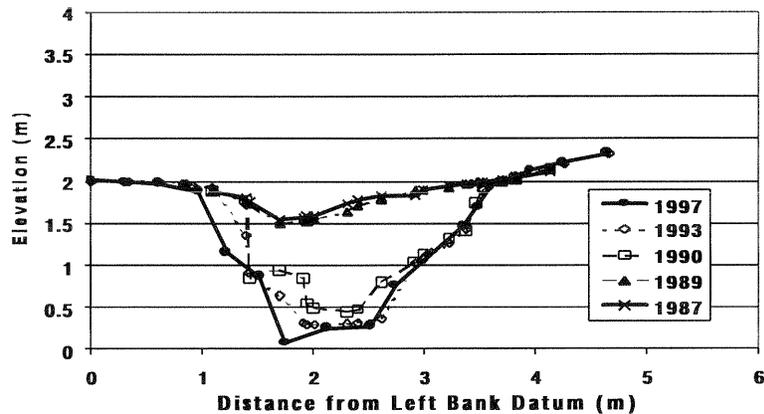
Figure 18. All cross section measurement of Station C8, the Timberline tributary that *does* receive significant stormwater runoff from the upslope development and which responded with abrupt downcutting in 1989-1990, and further incision by 1997..

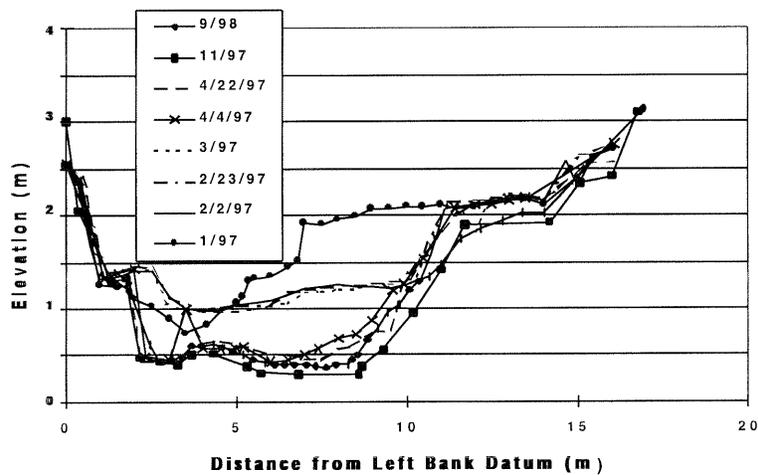
Figure 19. All measurements at Cross Section 4 of Boeing Creek, spanning 20 months since shortly after the site was obliterated by failure of the upstream detention pond embankment. Within weeks the channel achieved a “metastable” form that persisted for about two months (2/97-3/97); following several rainstorms in late March and early April 1997, channel form has remained nearly stable. Vertical exaggeration 2.5:1

In the final days of 1996, a major storm in the Seattle metropolitan area resulted in the failures of a road embankment and adjacent berm of a regional stormwater detention facility. Massive quantities of water and sediment were flushed down the North Fork and main stem of Boeing Creek, a stream draining several hundred hectares of primarily residential land use, and filled the valley of that channel as deep as 2 m with deposited sediment. Following this deposition, the channel of Boeing Creek began to reincise immediately, presenting an unexpected opportunity to document the establishment of a channel where watershed land cover was essentially stable (and highly developed) and the sediment to be eroded was very easily transportable by even modest stream discharges. Seven cross sections were established in the 300-m reach between the failed detention pond and Hidden Lake, an artificial pond that marks the downstream end of the alluvial channel on the main stem of Boeing Creek. The normal protocol of annual measurements was replaced by monthly, and in some instances weekly, field visits.

The recovery of the channel of Boeing Creek was anticipated to take a period of some years and to be controlled in part by the reestablishment of floodplain vegetation to help bind and stabilize the very sandy fill that was deposited. Instead, reestablishment of an apparently stable, “equilibrium” channel was very rapid and occurred at most cross sections in a matter of a few months (Figures 19 and 20). The subsequent year’s measurements demonstrated that this stability was not an artifact of the termination of rainfall in spring 1997; the 1998 channel, after another winter’s high discharges, remained largely unchanged.

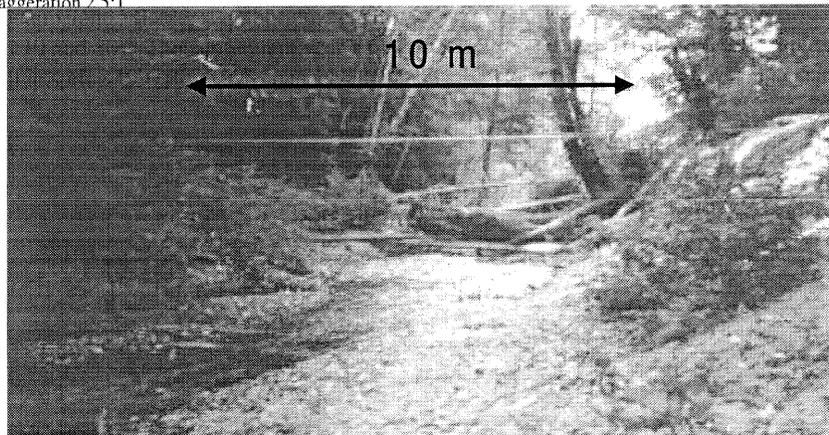
Figure 20. View of the channel of Boeing Creek (Station PS7) at Cross Section 4 on September 9, 1998 (the last measurement plotted in Figure 19), looking downstream.
